CALIFORNIA DIVISION OF MINES AND GEOLOGY
FAULT EVALUATION REPORT FER-185

SURFACE RUPTURE ASSOCIATED WITH THE NORTH PALM
SPRINGS EARTHQUAKE OF JULY 8, 1986--BANNING AND
RELATED FAULTS, RIVERSIDE COUNTY

By James E. Kahle, Earl W. Hart,
Glenn Borchardt, and Michael W. Manson
August 7, 1987

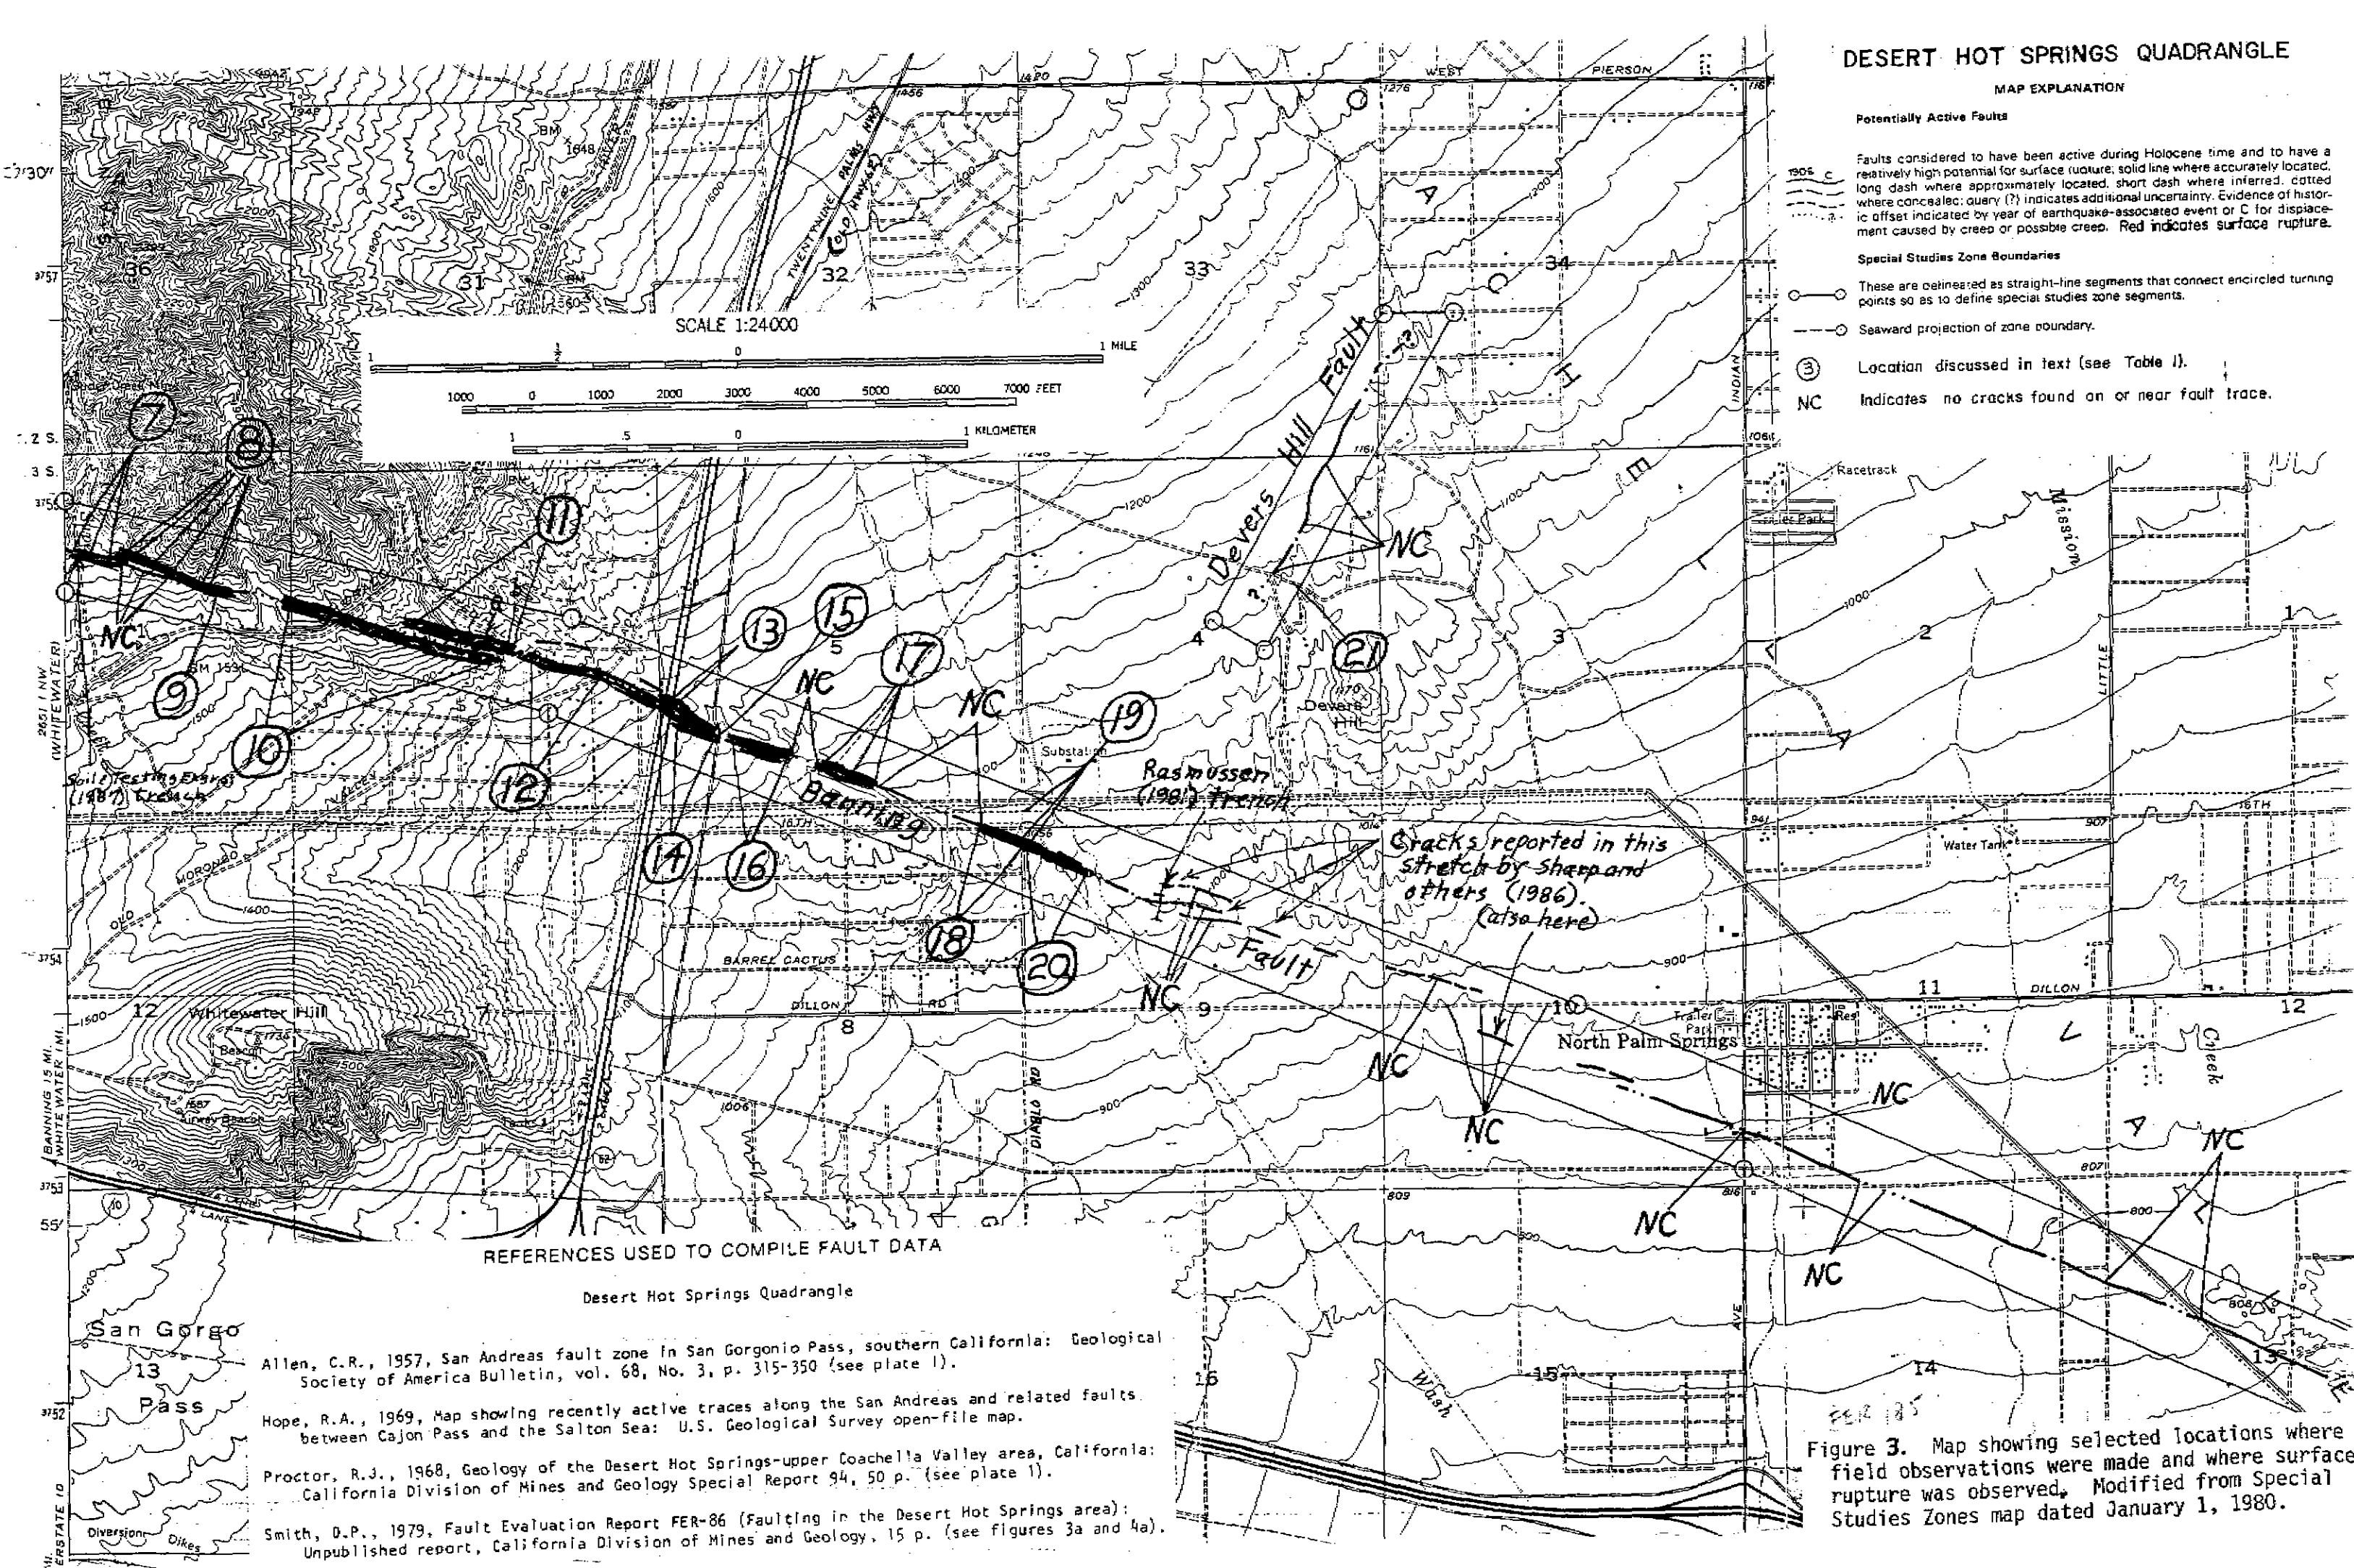
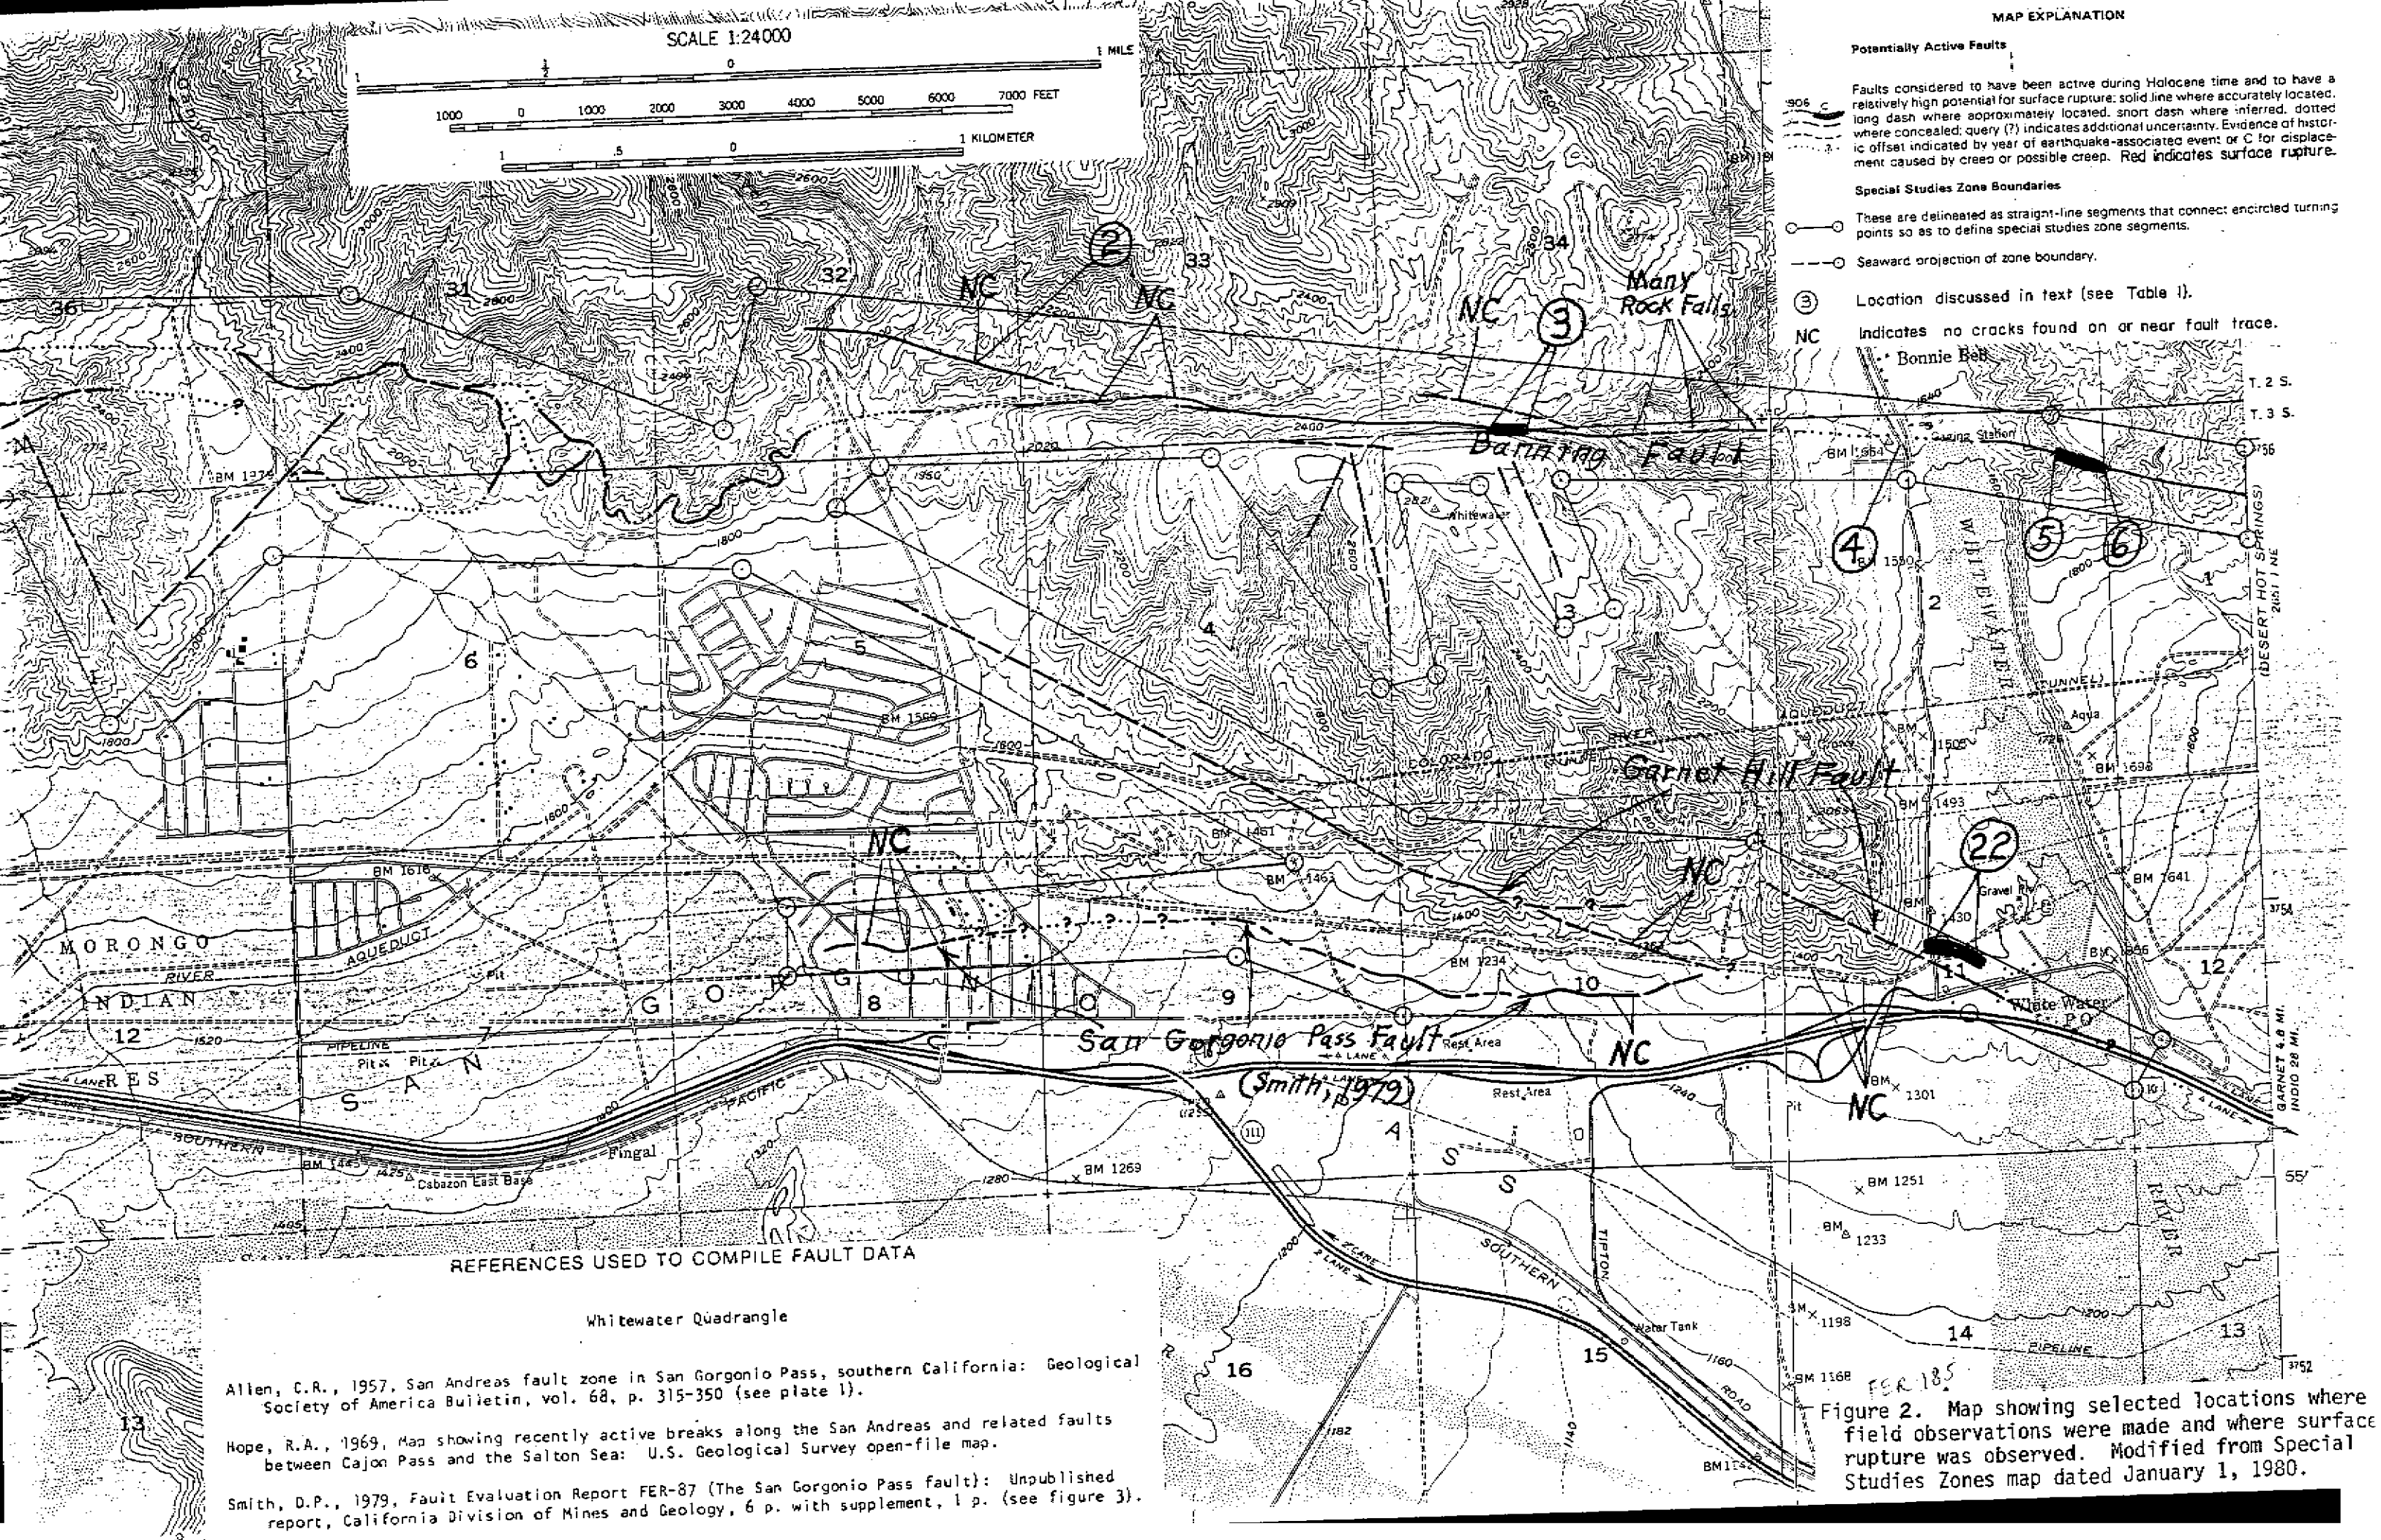
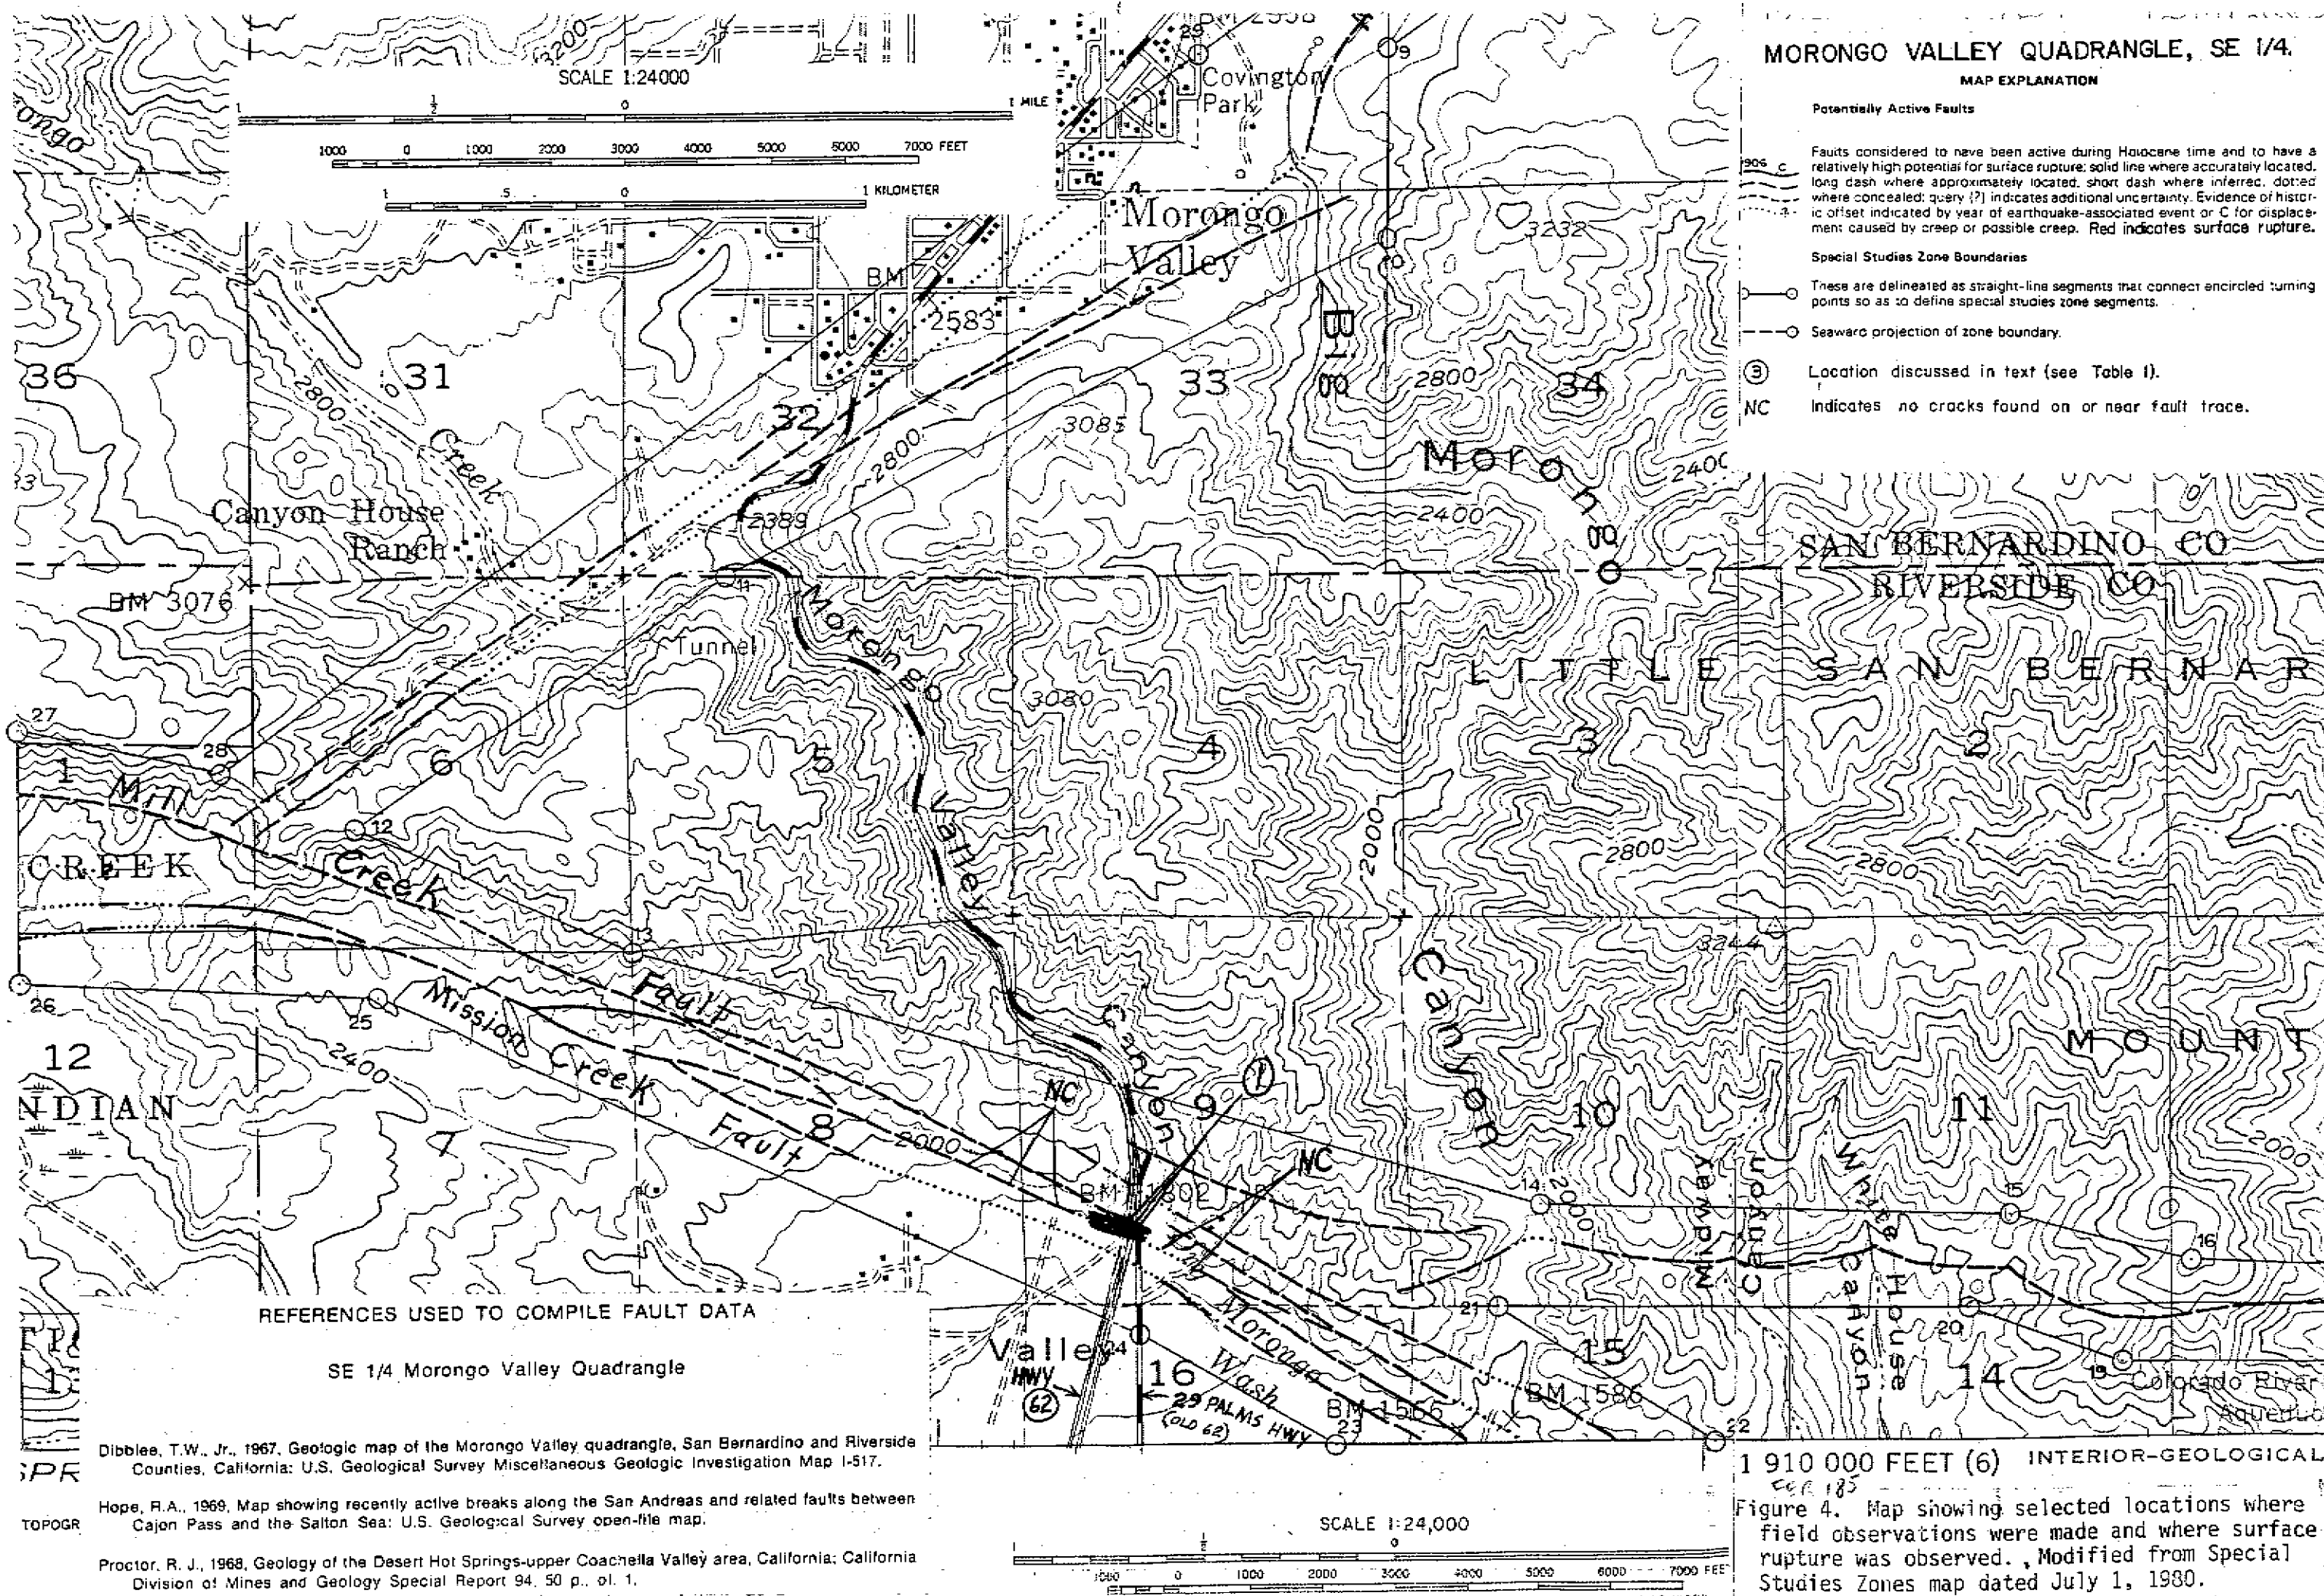
1910 000 FEET (6) INTERIOR-GEOLOGICAL
 Figure 4. Map showing selected locations where field observations were made and where surface rupture was observed. Modified from Special Studies Zones map dated July 1, 1980.

As can be seen from Figures 2, 3 and 4, all of the ruptures considered to be tectonic occurred within the SSZ's. Moreover, most of the rupture coincided with mapped traces of the Banning and Mission Creek faults. Only the short rupture segment of the Garnet Hill fault near Whitewater P.O. occurred near the SSZ boundary, but still was entirely within the SSZ.

From the viewpoint of the recent fault rupture, the SSZ maps appear to be adequate for development purposes. However, several fault segments zoned in the epicentral area may not meet our current zoning criteria of Holocene active and well defined (Hart, 1985), as suggested by the work of Clark (1984) and Matti and others (1985). When time permits, these and other SSZ's of the Transverse Ranges should be re-evaluated.

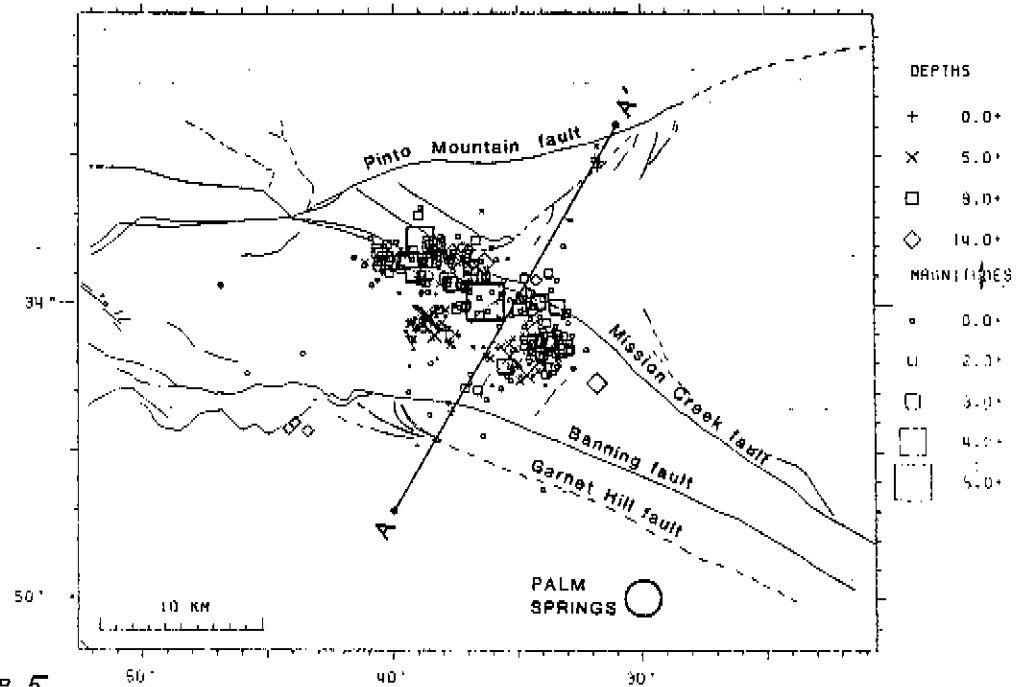
Figure 5.

The relationship of the NPS earthquake and its aftershocks to the above faults is shown in Figures 5 and 6. According to Jones and others (1986), the main shock had a focal depth of 11.3 km and a preferred focal plane of N60°W, 45°NE. The first motion on this plane indicates pure right-lateral slip. The data generally suggest the Banning fault as the causative earthquake fault. This is further supported by the aftershocks, which plot on a plane that dips 50-60°NE (Figure 6). However, the aftershock plane does not extend within 4km of the surface.

FIG. 2. The epicentral locations of the main shock and located aftershocks of the 8 July 1986 North Palm Springs earthquake ($M_L = 5.9$). The line A-A is the projection line for the cross-section in Figure 3. Fault traces are after Matti *et al.* (1985). (From Jones and others, 1986, Fig. 2).

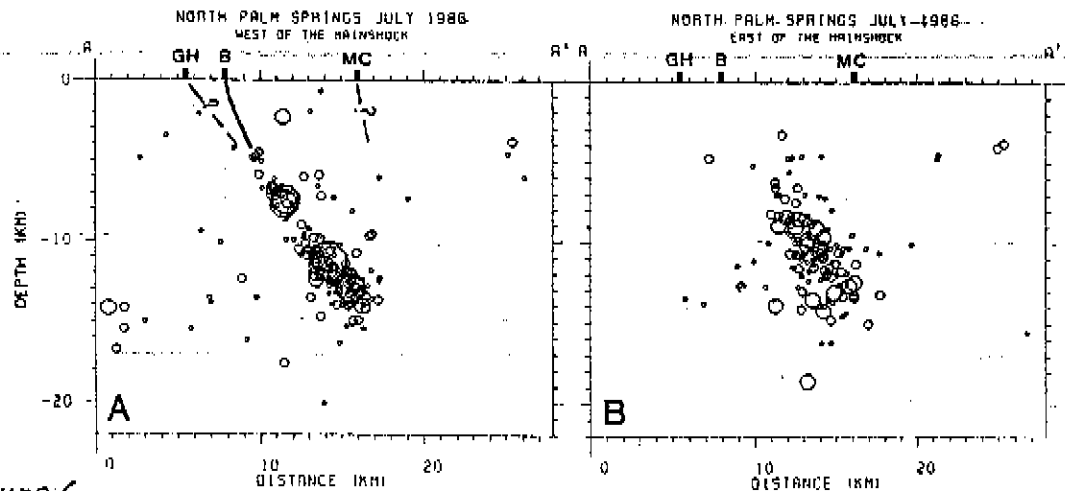
Figure 6.

FIG. 3. The depths of the main shock and located aftershocks of the 8 July 1986 North Palm Springs earthquake ($M_L = 5.9$) plotted against their projection onto the line A-A' shown in Figure 2. The points where the Garnet Hill (GH), Banning (B), and Mission Creek (MC) faults cross A-A' are marked. Aftershocks west of the main shock (A) and east of the main shock (B) are shown separately. (From Jones and others, 1986, Fig. 3).

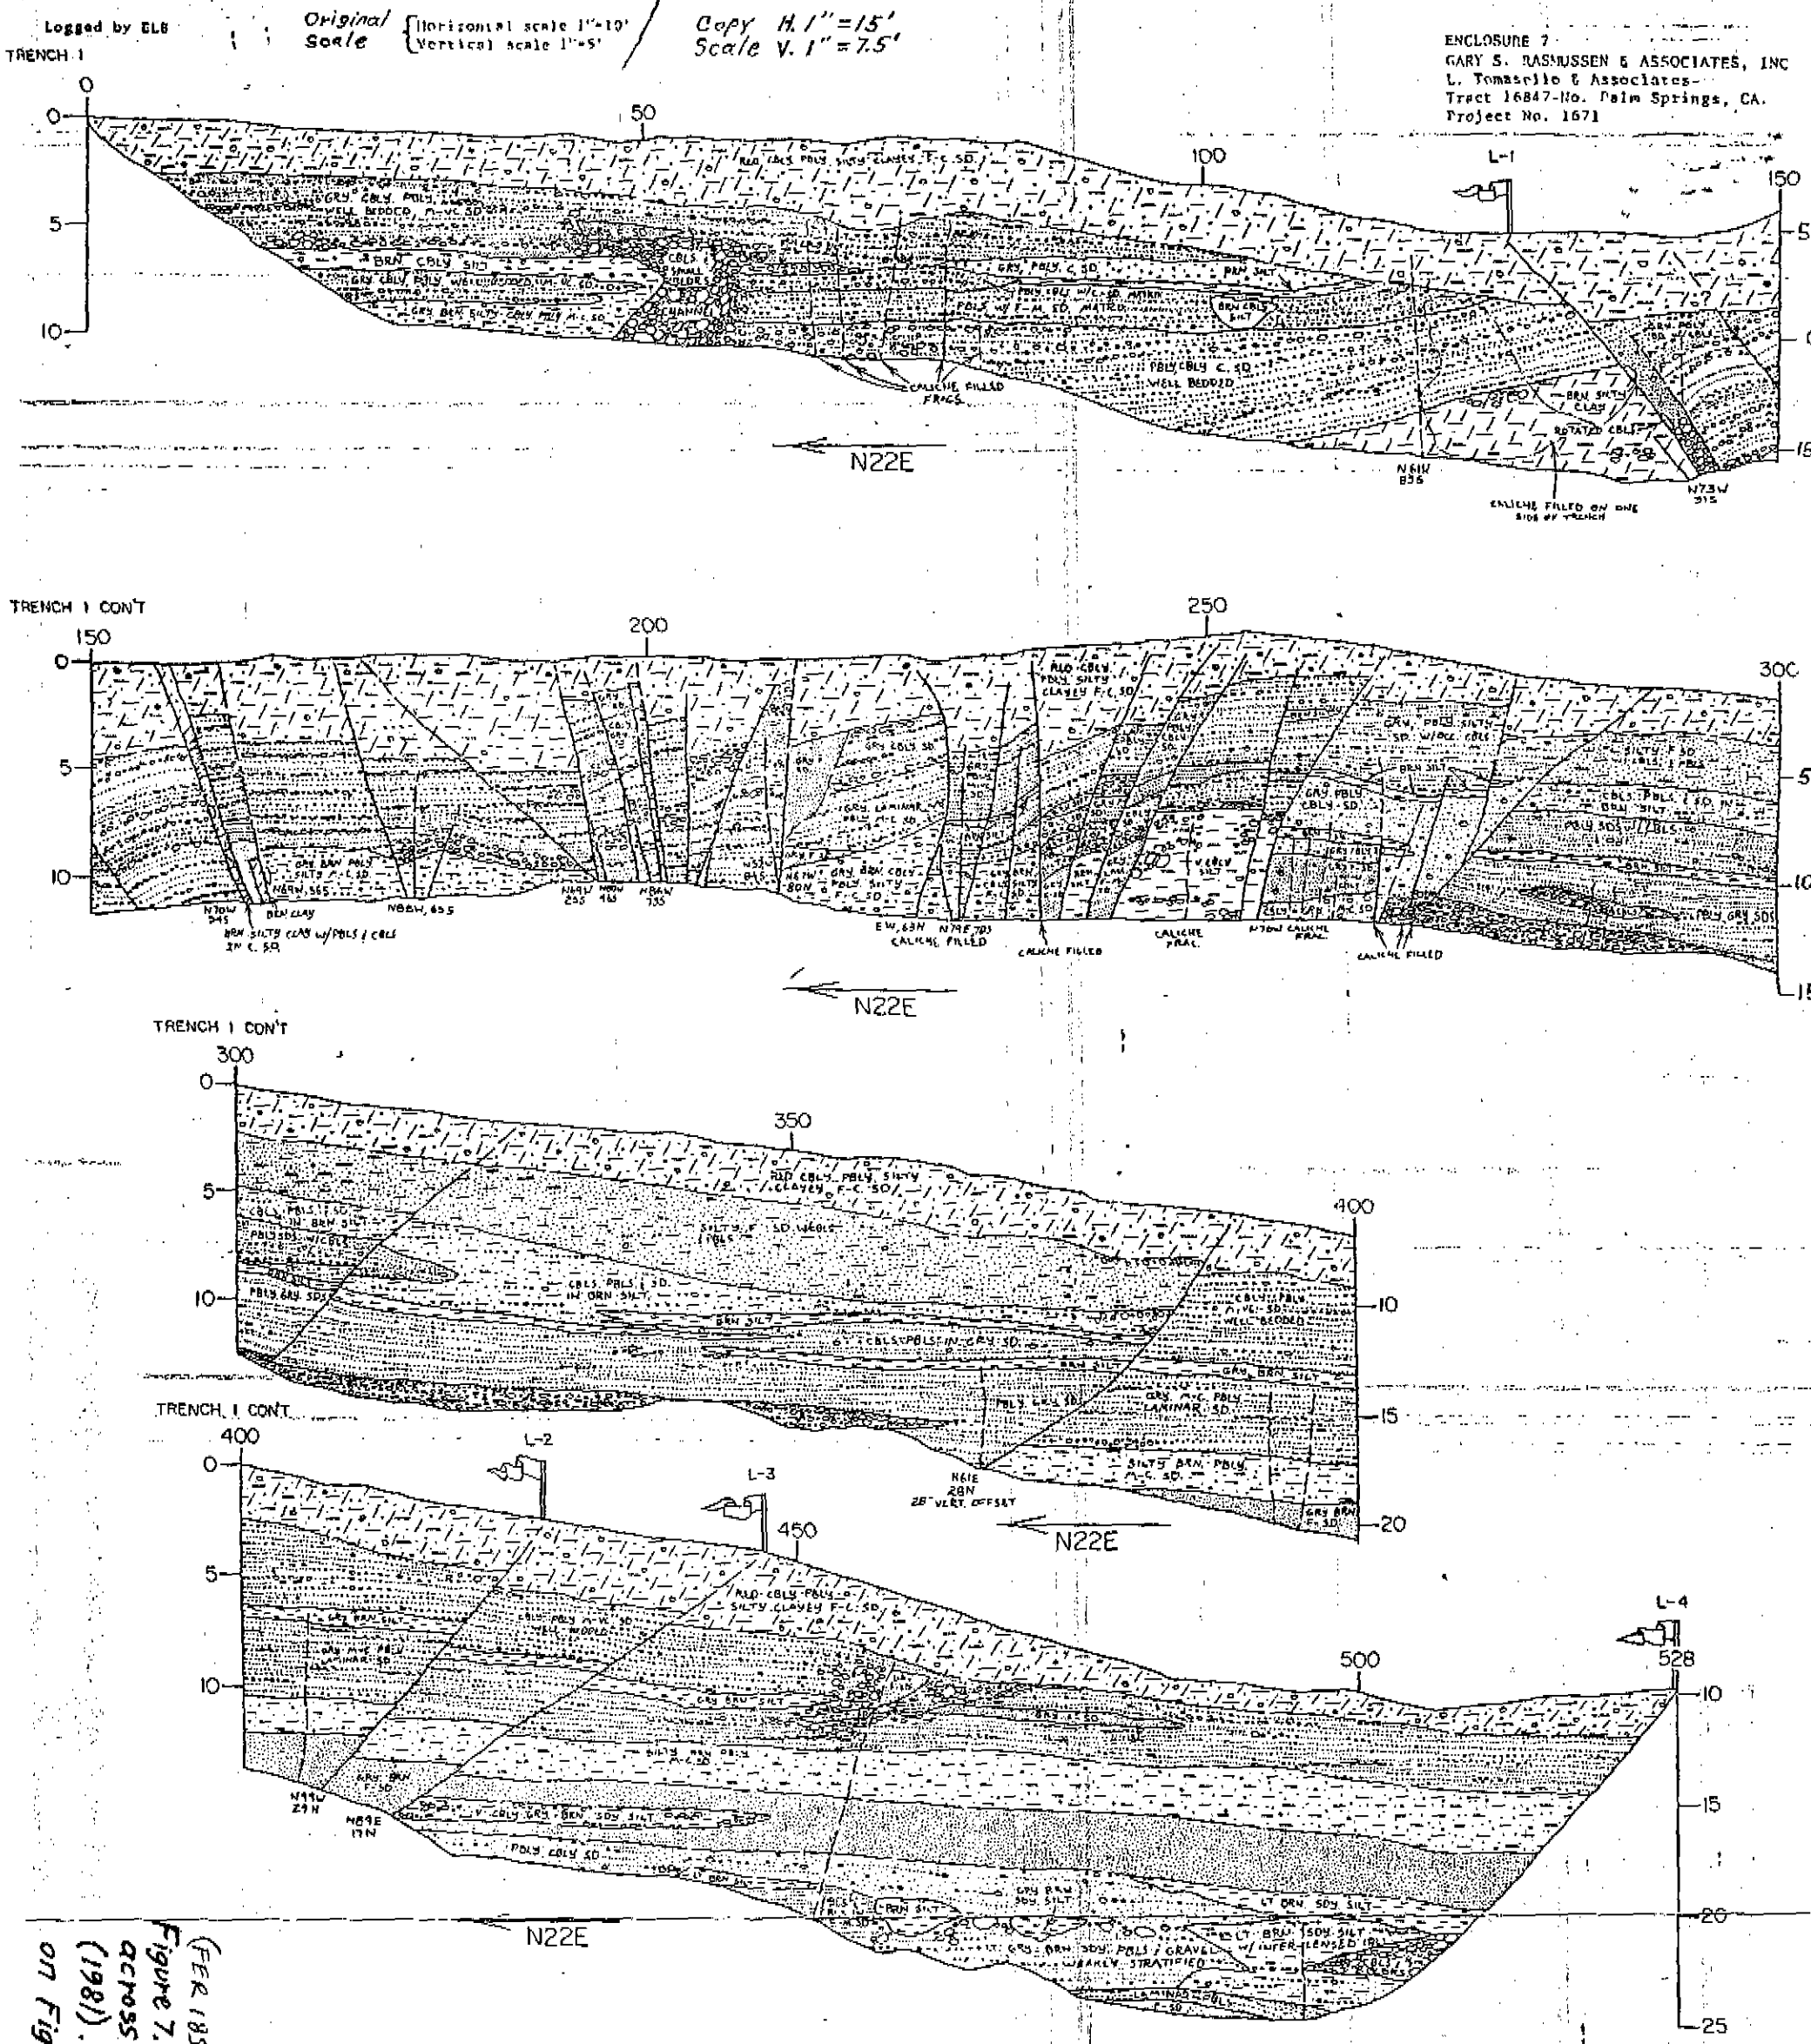
(FER 185)
Figure 7. Reduced-scale log of trench across Banning fault, from Rasmussen (1981). Approximate location is shown on Figure 3,

- (7). Cracks in alluvium on projection of fault trace. Few features from previous faulting present here but cracks occur in both older alluvium or fan debris and youngest active stream channel. Cracks not continuous or en echelon and do not appear to be rotated either clockwise or anticlockwise. Area between here and location (6) not investigated; dispersed, noncontinuous and ambiguous cracking reported by others (R.V. Sharp and D.M. Morton, personal communication; Sharp and others, 1986). Trench in Super Creek by Soil and Testing Engineers (1987) shows Holocene alluvium offset by 4 steeply dipping faults over a zone 62 meters wide.
